EFFECTS OF DEEP- AND SHALLOW-OCEAN ENVIRONMENTS ON CONSTRUCTION MATERIALS

Comparison of fouling and corrosion produced by prolonged submergence
of selected materials, with and without protective coatings

Research and Development Report

NAVAL ELECTRONICS LABORATORY CENTER
San Diego, California 92152

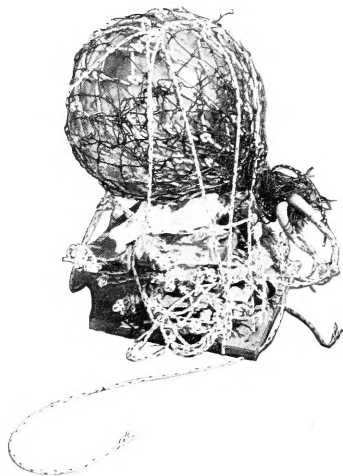
Figure 3. Test assembly in original sandwich arrangement, as retrieved from USS SQUAW after three months of submergence.

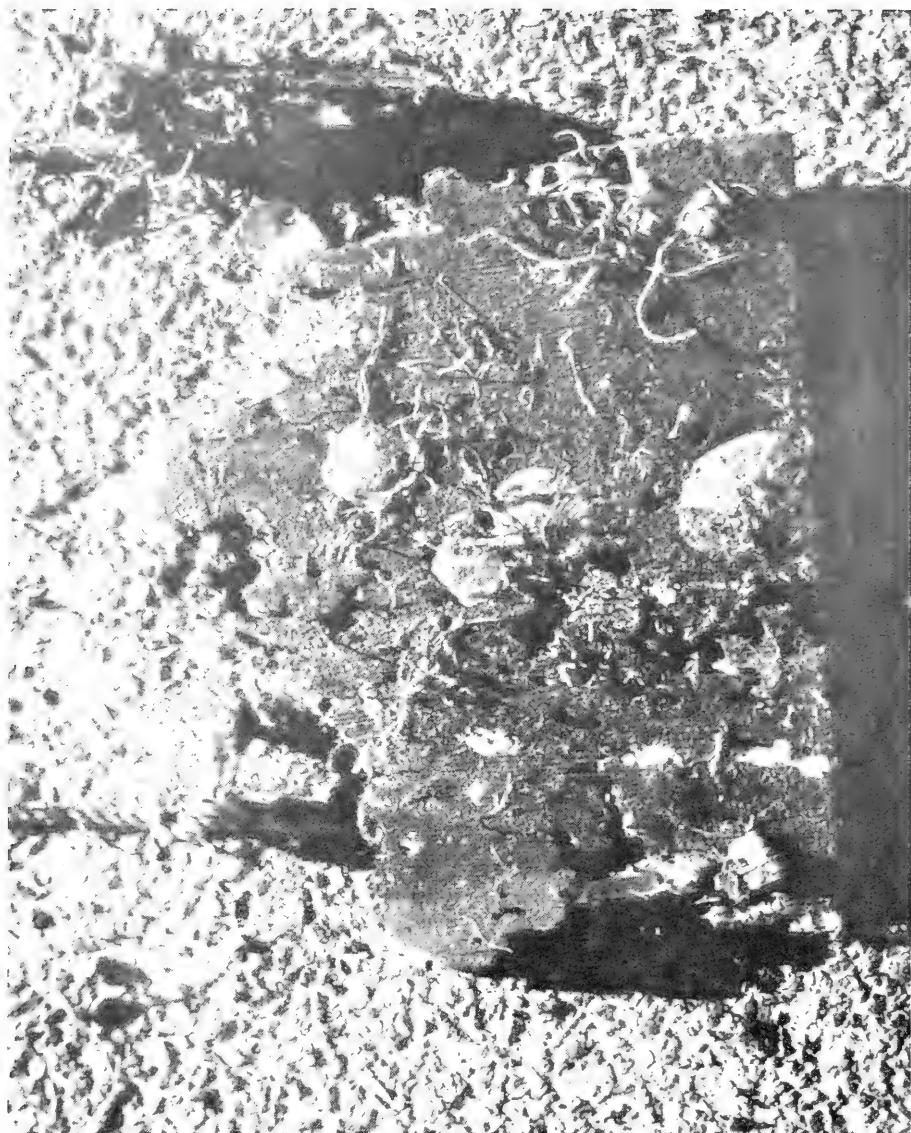
The Douglas fir panels differed in their ability to resist biological borers. The shallow-water panel maintained its entire outline, while the deep-water sample was almost destroyed. It may be that the fouling elements at the shallower location, finding lodgement and rapid growth possible on the bare wood, grew so rapidly that they made penetration by the borers more difficult. A corresponding effect was noted on the aluminum plates; the deep-water panel was severely corroded over its entire surface, while that from the shallow water had apparently been protected by the heavy growth of fouling organisms.

Figure 5. Douglas fir panel after submergence in SQUAW installation.

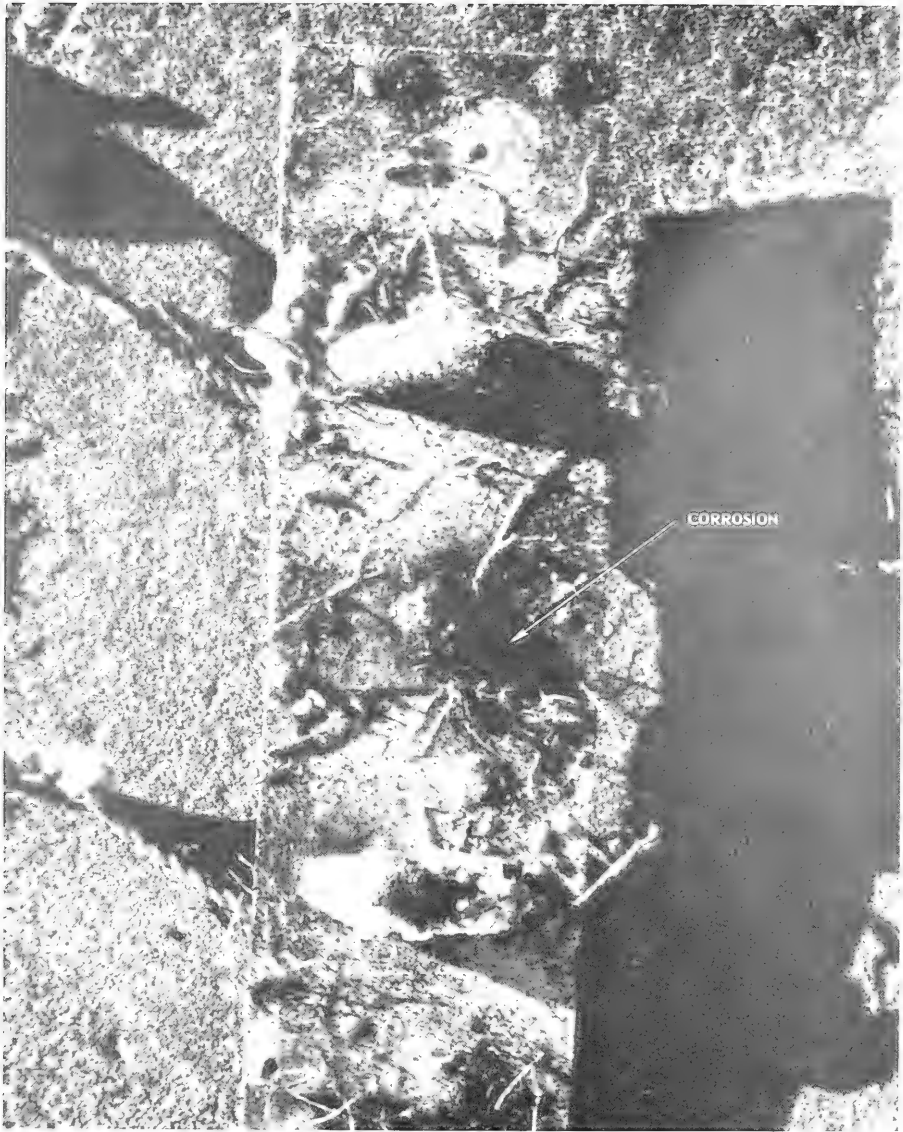
The "corrosion resistant" steel proved to be more subject to corrosion and fouling than is generally believed. The more severe corrosion of the sample from the SQUAW might indicate the effect of pressure at greater depth or, possibly, as in the case of the wood and aluminum panels, the heavier biological fouling in the shallower environment protected the sample there from corrosion.

Figure 9. Corrosion-resistant steel panel (#8), uncoated, after submergence in SQUAW installation.

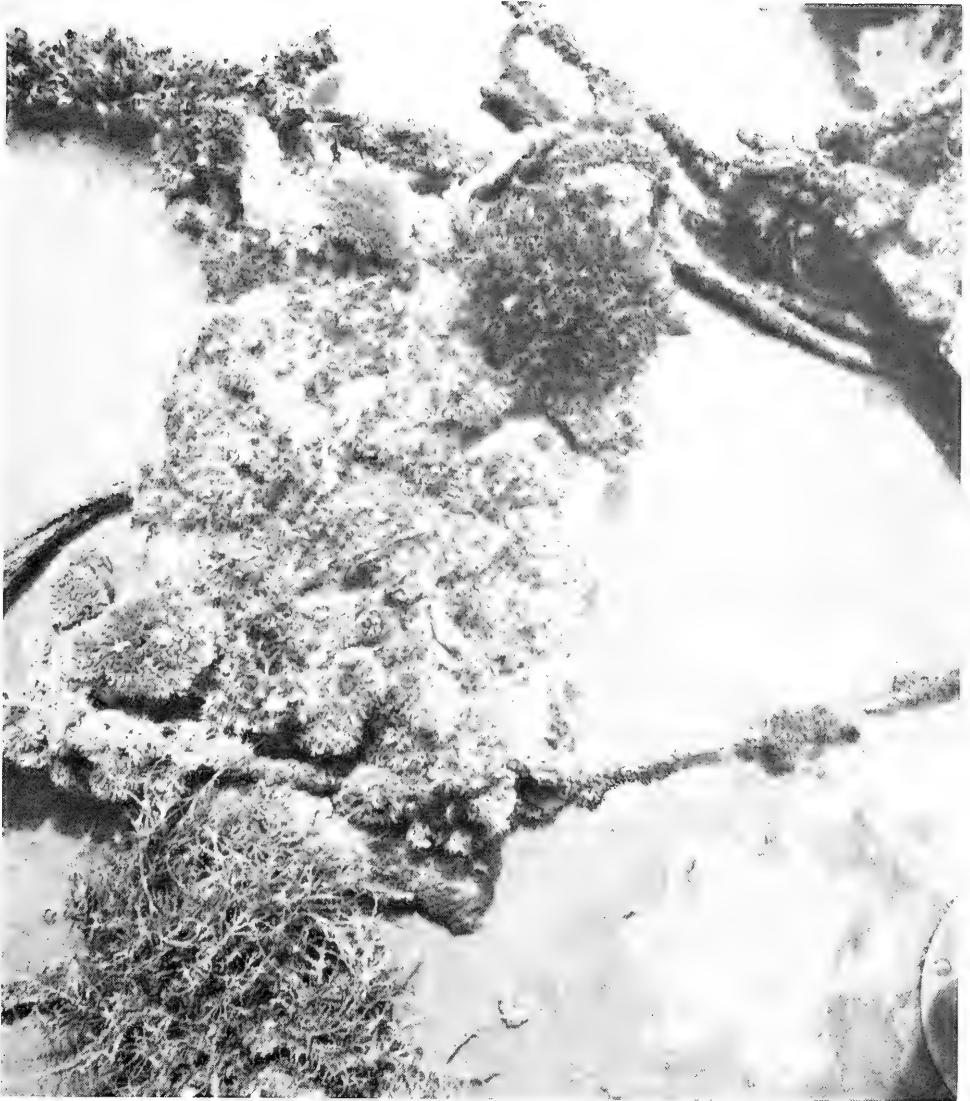
Figure 10. Steel panel (#9), coated with corrosion-resistant and tri-butyl-tin oxide antifoulant, after submergence in Tower installation.

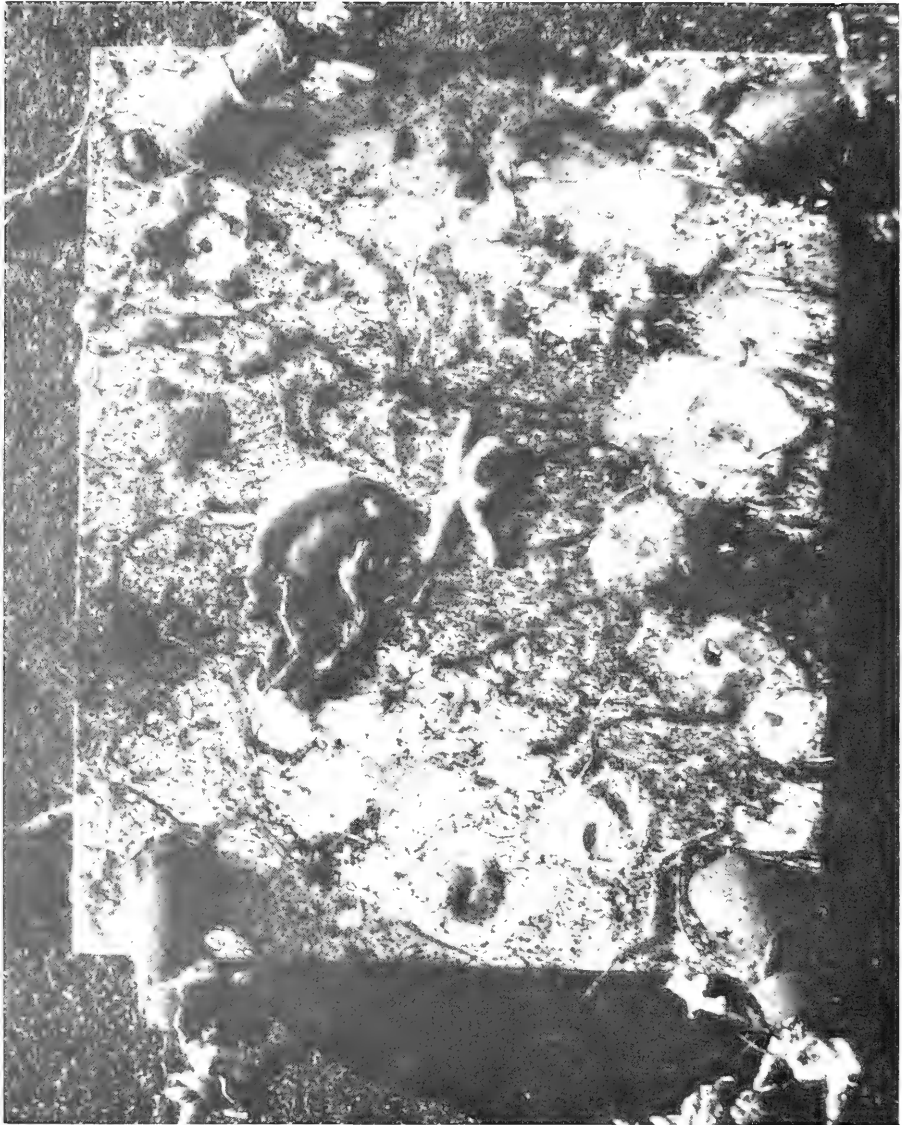
Figure 11. Steel panel (#9), coated with corrosion-resistant and tri-butyl-tin oxide antifoulant, after submergence in SQUAW installation.
